THE MAN-MADE MC MURDO ICE WHARF--
HISTORY, CONSTRUCTION AND PERFORMANCE

J. L. Barthelemy

Civil Engineering Laboratory (Navy)
Port Hueneme, California

February 1975

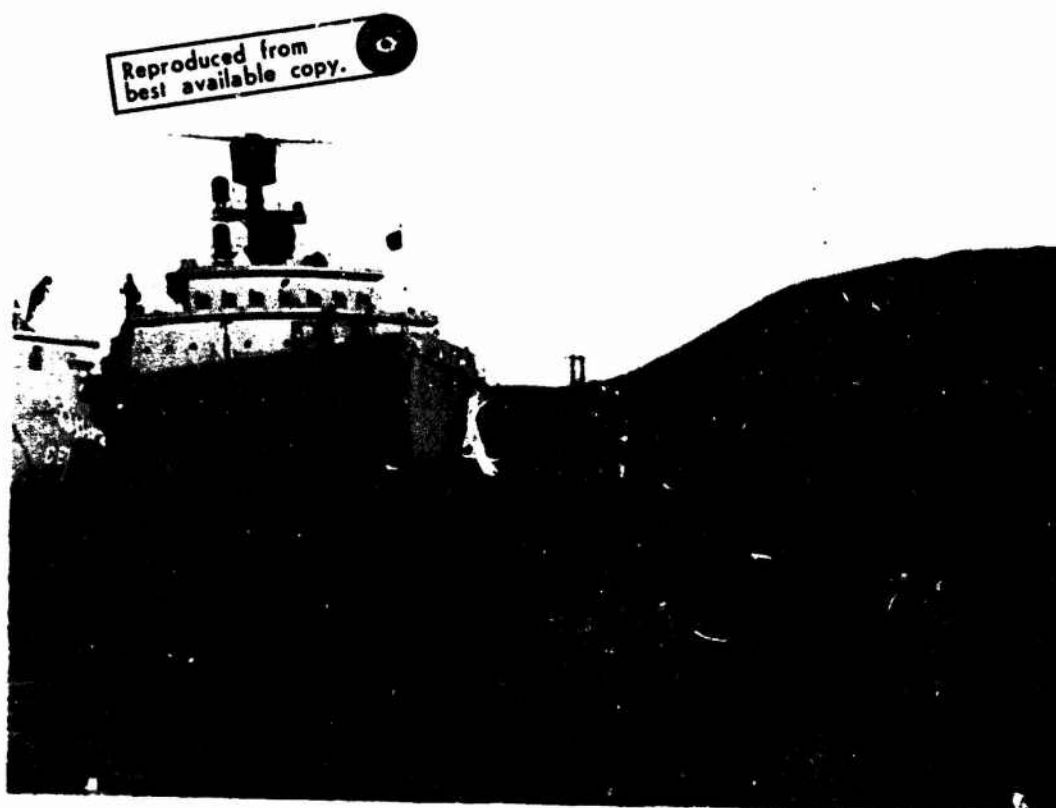
Figure 2 shows the smooth face of the ice shelf during DF-65. Unfortunately, removal of the annual ice around Hut Point was deleterious to wharf survival. The vertical face, no longer protected by a buffer of sea ice, was exposed directly to ablative melting caused by

Figure 2. View of the smooth, natural ice wharf face during DF-65.

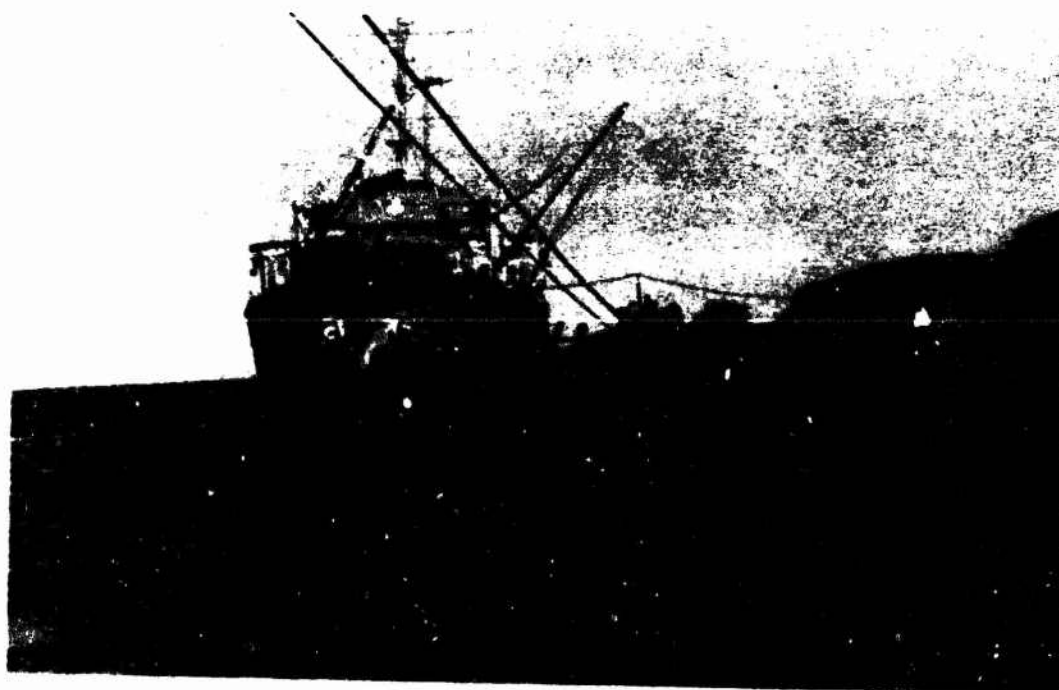
wave action and ship discharge. The result was undercutting. Melted caverns formed at sea level, creating cantilevered lips which would periodically break off unevenly, giving the vertical ice face a jagged and protuberant appearance. Figure 3 shows the effects of ablative melting. In 1969, it was estimated that each year 10,000 square feet of surface area was lost to wave action [3]. Even more serious than the loss of cargo-handling area, however, was the reduced depth of water alongside the wharf. Figure 4 shows how ablation along the seaward face caused the fast ice to recede into the shallower waters near shore.

Figure 3. Jagged appearance of ice face due to un ercutting after DF-65.

In order to prevent further wave damage, and also maintain a vertical docking surface, the Naval Facilities Engineering Command (NAVFAC) designed a protective dock face. In a 4-year period ending in DF-72, a total of 464 feet of steel and timber facing was installed [4]. Structural beams, placed on the wharf and anchored to piles set in the ice, were used to support a vertical, steel framework with timber panel inserts. This network, which extended from approximately 10 feet above sea level to 20 feet below, prevented wave penetration. A volcanic fill material was packed between the facing and natural ice face to provide additional protection. Figure 5 presents a closeup view along a section of the dock facing. During March 1972, a major portion of the wharf was either destroyed or severely damaged by storm. High tides and pounding ice ripped out many of the steelfaced timber panels, bending the I-beam supports and washing away most of the fill. Unprotected portions of the natural ice face were extensively eroded.

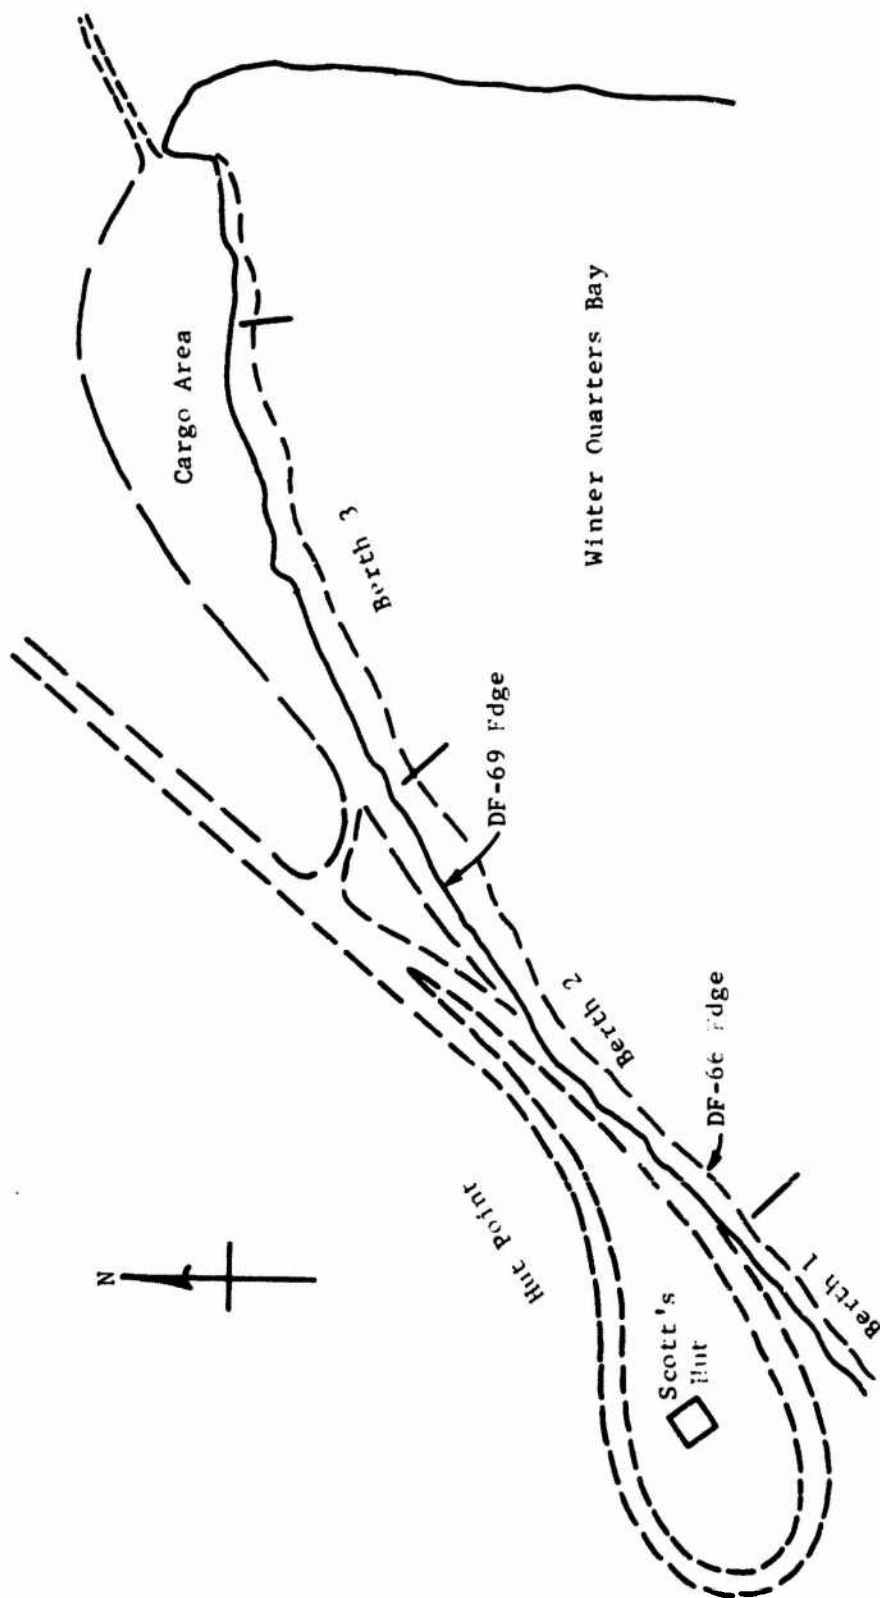
Figure 4. Sketch showing ablation history of natural ice wharf.

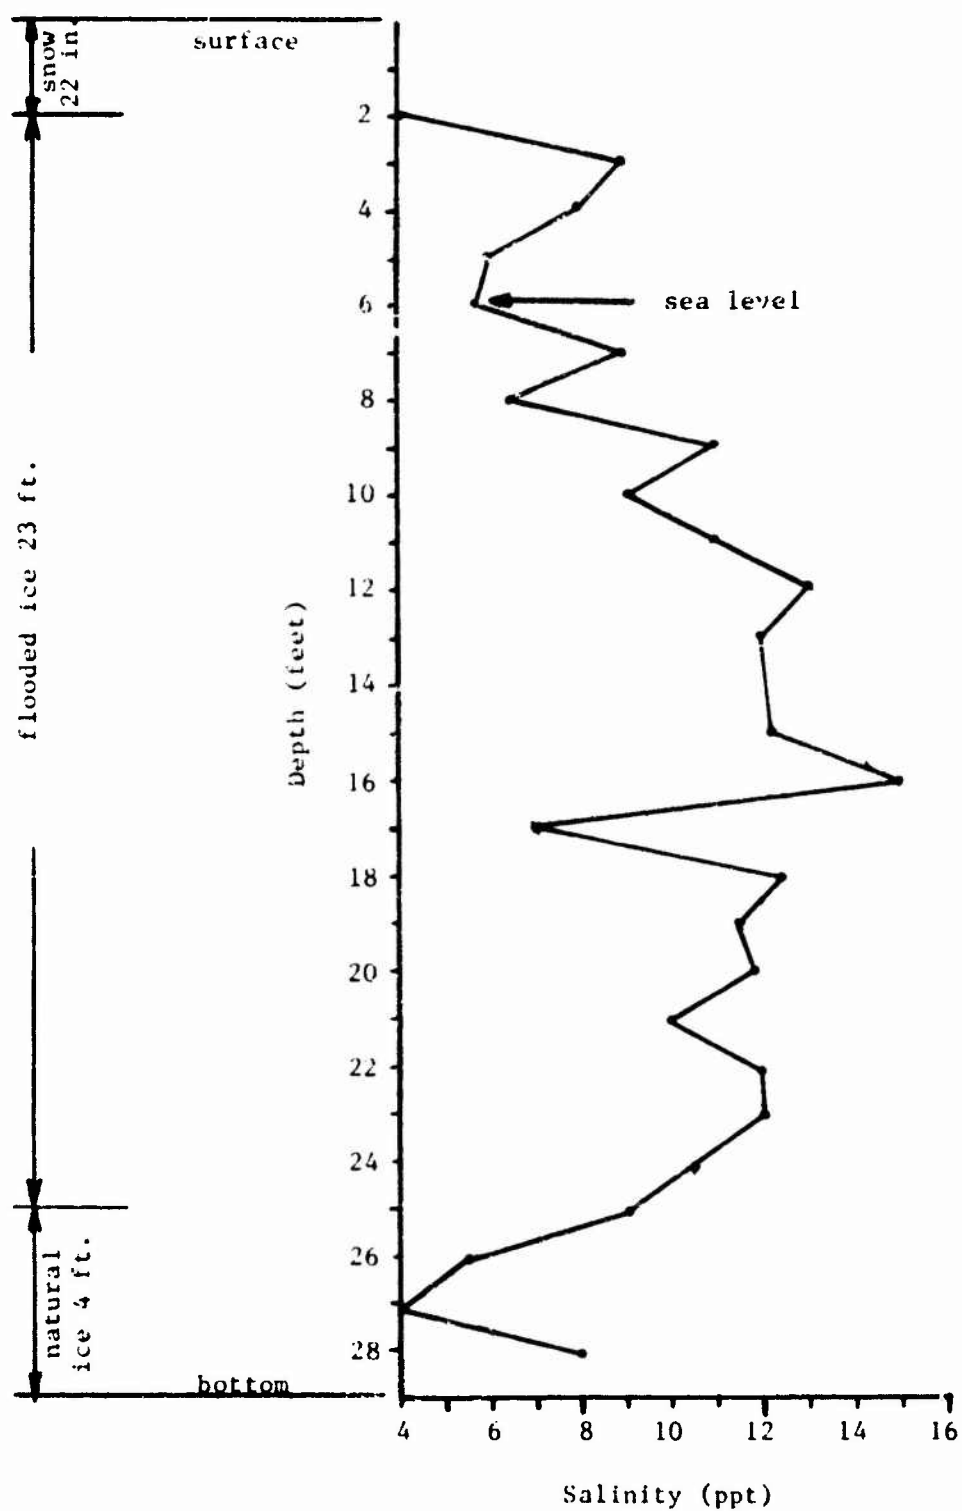
The results of the salinity measurements made at 1-foot intervals are shown in Figure 6. The highest salinity measure was 15 parts per thousand (ppt) with an average of 9.7 ppt. This was about twice the average salinity for 1-year-old sea ice but again was considered normal for the flooded ice at that time.

Figure 6. Salinity profile of core extracted from surface-flooded ice wharf, 25 November 1973.

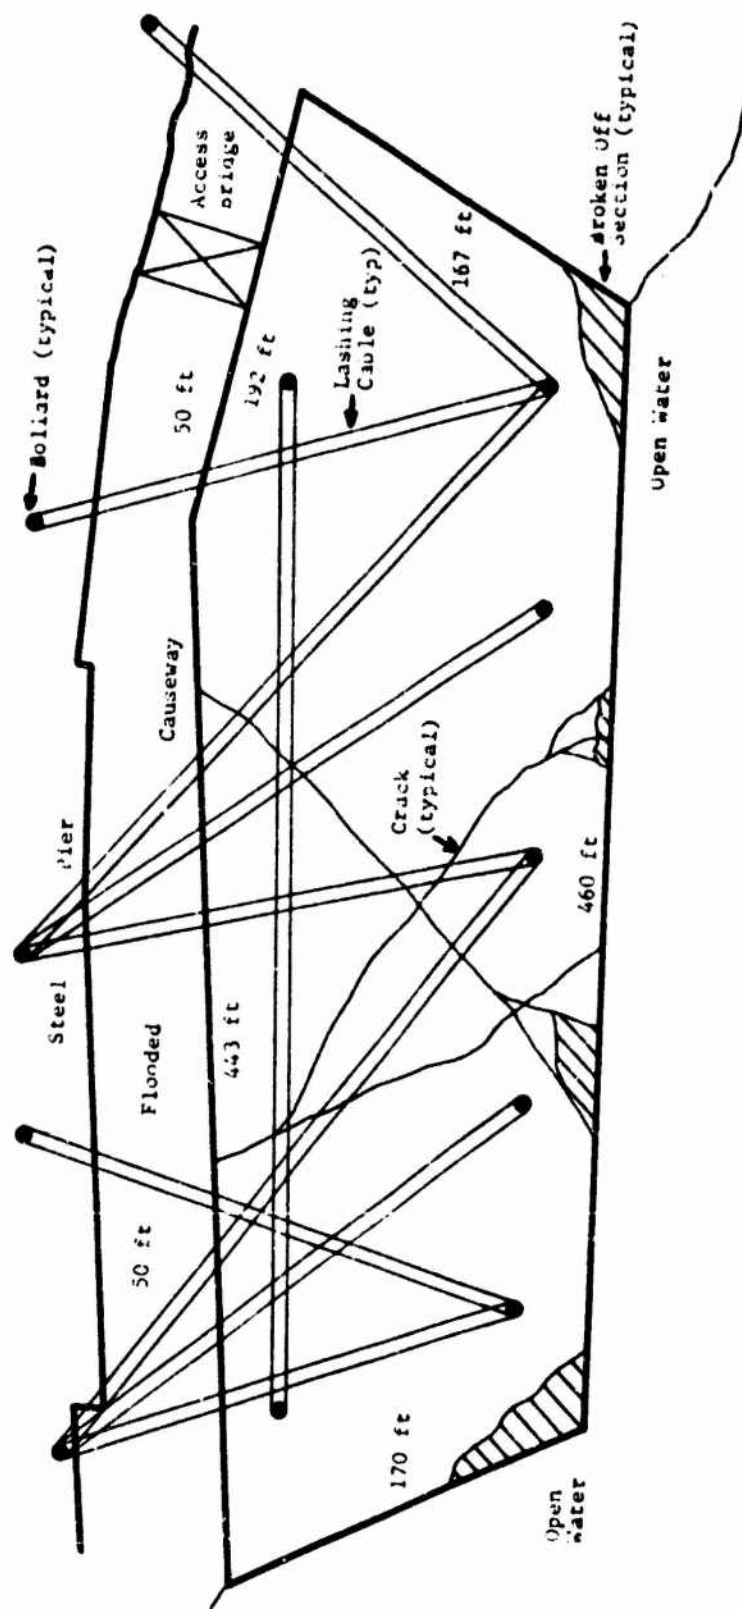
The ice breaker *USCG Staten Island* moved into Winter Quarters Bay on 15 January to remove ice from the vicinity of the wharf. Initial passes were intended to break up the annual ice at some distance from the structure. Even so, a crack which began in the annual ice continued to propagate through the wharf, all the way to the tidal crack. In addition to this major full-depth crack, there were other hairline fractures. Operations were halted and two bollards installed in order to tie the two sections together.

The next day the ice breaker resumed maneuvers. It made good progress on clearing the wharf face. On the last pass, however, the ship moved too closely, and the resulting impact opened up several new full-width, full-depth cracks. Also, an end piece totally separated and floated away. The remaining sections were large and worth saving; two additional bollards (for a total of seven) were added, and the entire network lashed together. Figure 8 presents a sketch which shows crack and bollard configuration at the time of cargo unloading.

Figure 8. Surface-flooded McMurdo ice wharf during breakout, 16 January 1974.
